**RE: Parkhill Lagoon Annual Report 2025**

# 2025 Parkhill Lagoon Annual Performance Report

Reporting Period: January 1 – December 31, 2025

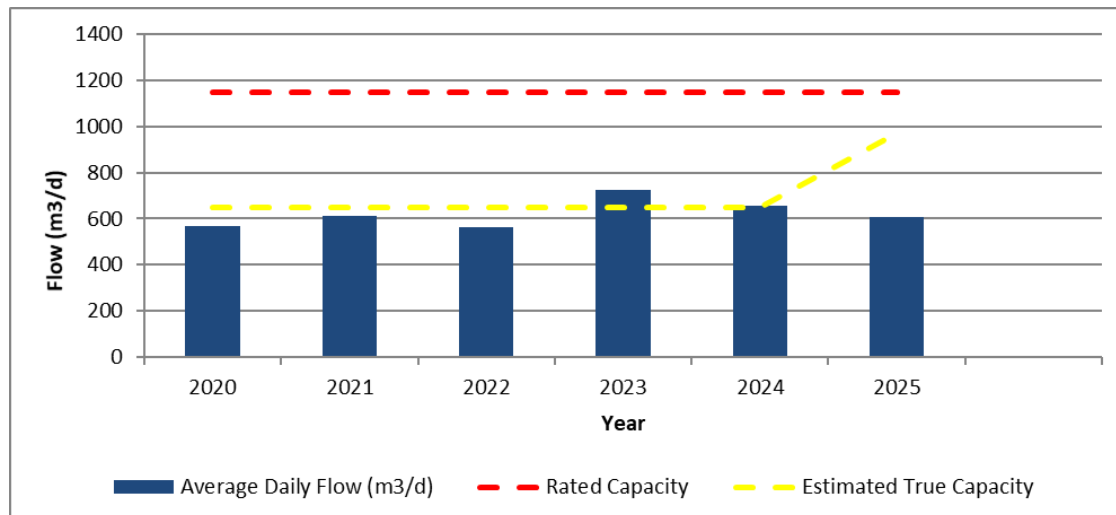
Figure 1: Influent Flows 2020-2025

The Parkhill Sewage Lagoon is rated to treat an average flow of 1150 m<sup>3</sup>/d. In 2025, the Parkhill Sewage Lagoon operated at 52% of the ECA rated capacity (refer to Figure 1). In 2024, R.V. Anderson and Associates Limited completed a capacity assessment of the lagoons that considered the 2024/2025 biosolids removal and the historic capacity of the Parkhill Lagoon to meet ECA effluent objectives and limits. They estimated a capacity of 970 m<sup>3</sup>/d. Using this measure, the Parkhill Lagoon is currently at 63% capacity. A 2023 capacity assessment had previously rated this capacity at 647 m<sup>3</sup>/d as reflected in Figure 1 below.

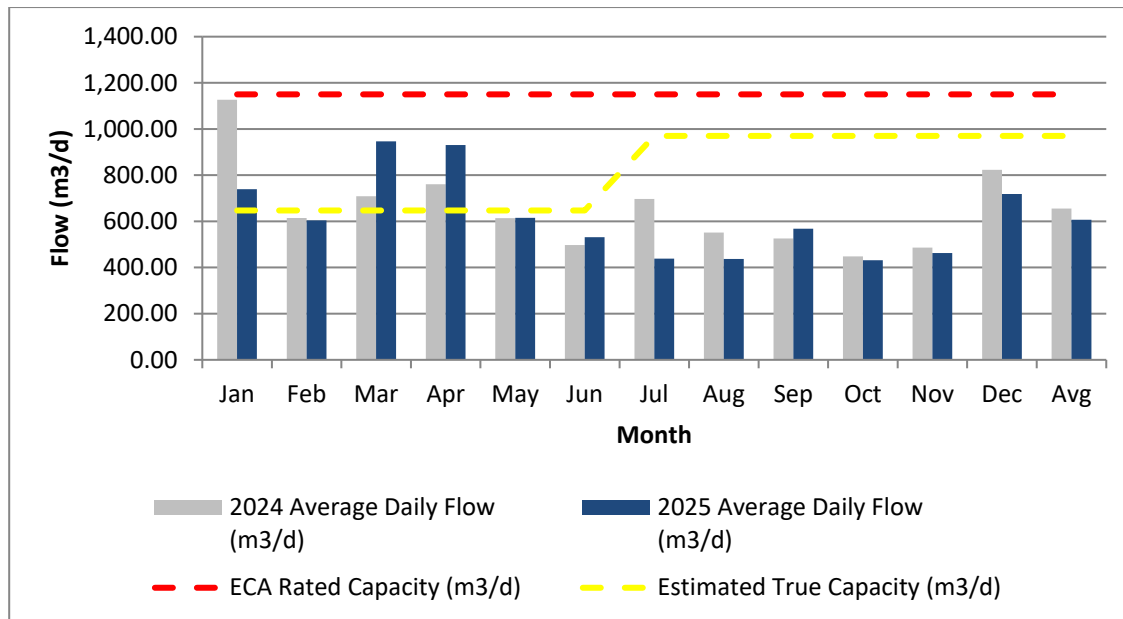
Figure 2: Average Daily Flows by Month

In 2025, the raw sewage average daily flow was 606 m<sup>3</sup>/d versus 656 m<sup>3</sup>/d in 2024 (refer to Figure 2). This 7% reduction is attributed to the drier conditions during the 2025 reporting year.

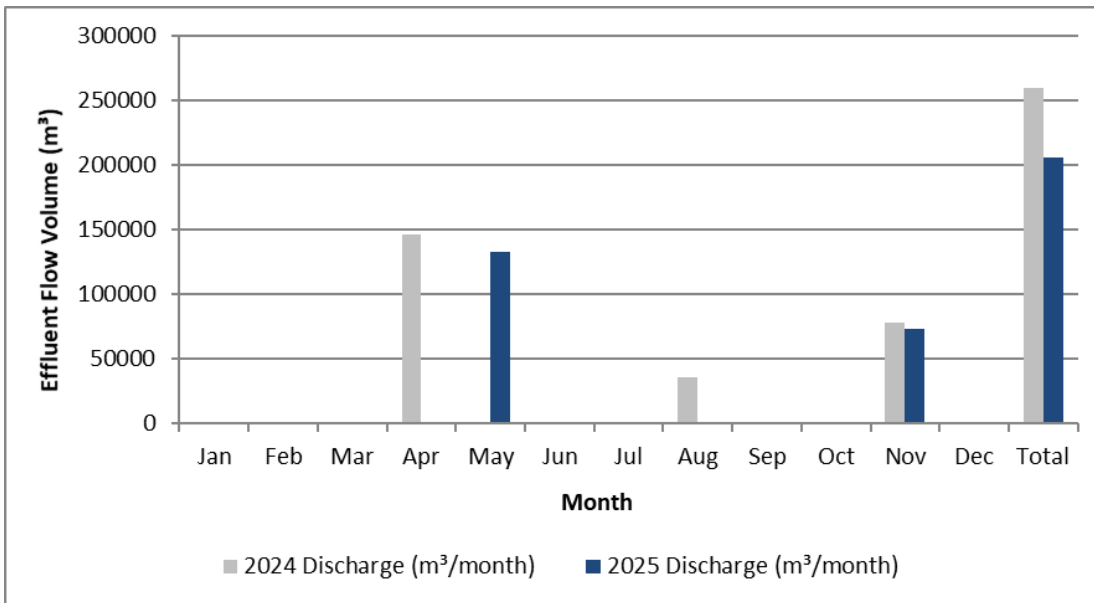
Figure 3: Effluent Flow Volume 2024 and 2025

Typically, the Parkhill Lagoon discharges seasonally—once in the spring and once in the fall. In 2024, an additional discharge occurred in August to facilitate the removal of biosolids in the south lagoon cell. In 2025, seasonal discharges occurred from May 2<sup>nd</sup> to May 16<sup>th</sup> and November 5<sup>th</sup> to November 21<sup>st</sup>. The total volume discharged was 205,550 m<sup>3</sup>, compared to 259,653 m<sup>3</sup> in 2024 (refer to Figure 3). This 20% reduction in discharge volume is partially attributed to a decrease in raw influent flow resulting from drier weather conditions, which reduced wet-weather inflow and infiltration. Evaporative losses during warmer and drier periods may have also contributed to reduced lagoon volumes. In addition, biosolids removal completed in 2024 and 2025 restored available storage capacity and may have improved hydraulic performance by increasing effective retention time and reducing short-circuiting, allowing greater volumes to be retained within the lagoon system.

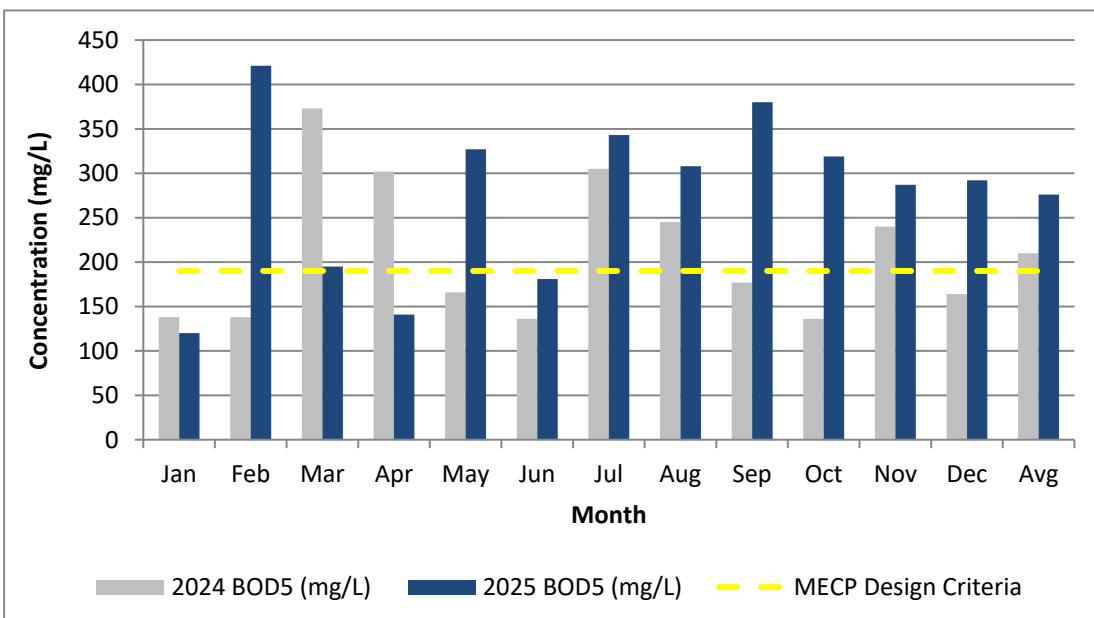
Figure 4: Raw BOD<sub>5</sub> Concentrations 2024 to 2025, compared to Raw Design Criteria

In 2025, the average raw BOD<sub>5</sub> concentration was 276 mg/L, which is a 31% increase from the average concentration in 2024 (refer to Figure 4).

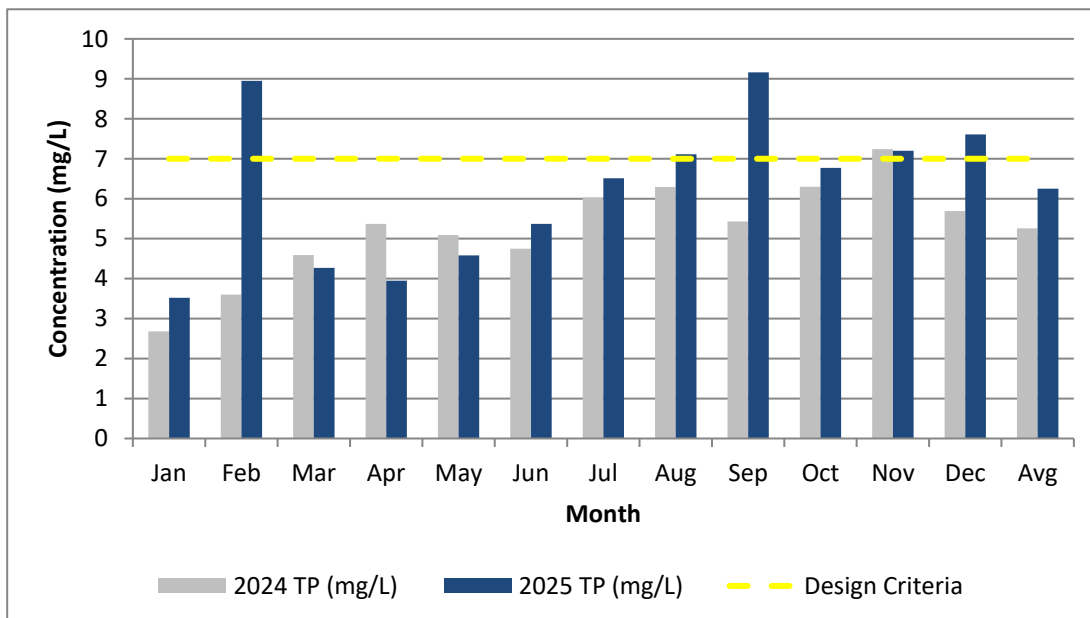
Figure 6: Raw TP Concentrations 2024 to 2025, compared to Raw Design Criteria

In 2025, the average raw Total Phosphorus concentration was 6.3 mg/L, which is a 19% increase from the average concentration in 2024 (refer to Figure 6).

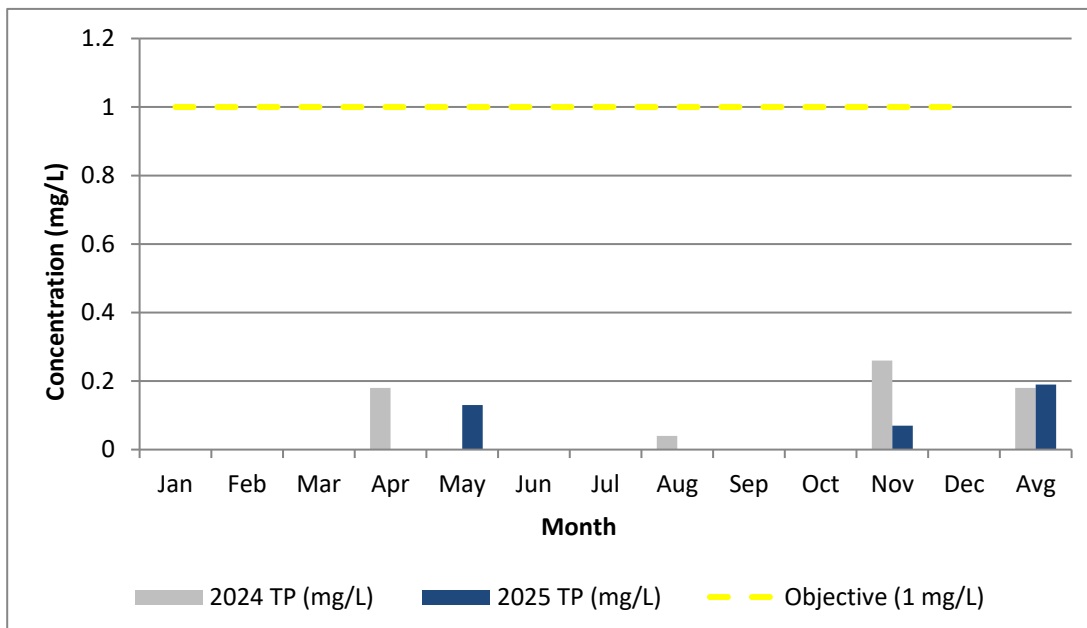
**Figure 10:** Effluent TP Concentrations 2024 to 2025, against ECA Objective

In 2025, the average effluent Total Phosphorus concentration was 0.19 mg/L, which is a 6% increase compared to the average concentration in 2024 (refer to Figure 10). The ECA annual average objective was met.

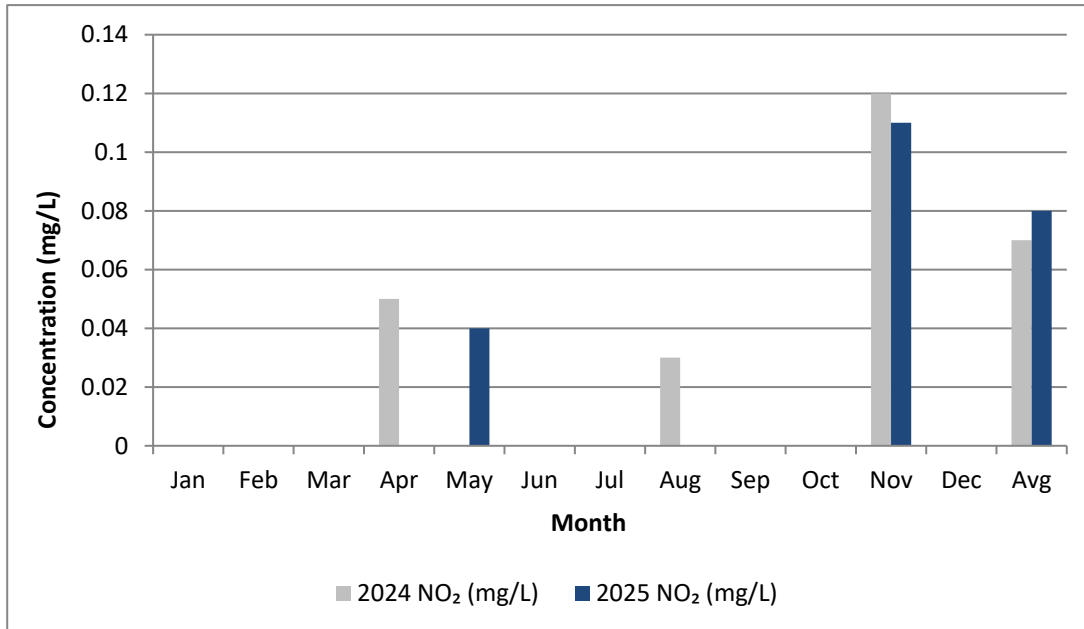
Figure 13: Effluent  $\text{NO}_2$  Concentrations 2024 to 2025

In 2025, the average effluent Nitrite was 0.08 mg/L, which is a 14% increase compared to the average concentration in 2024 (refer to Figure 13).

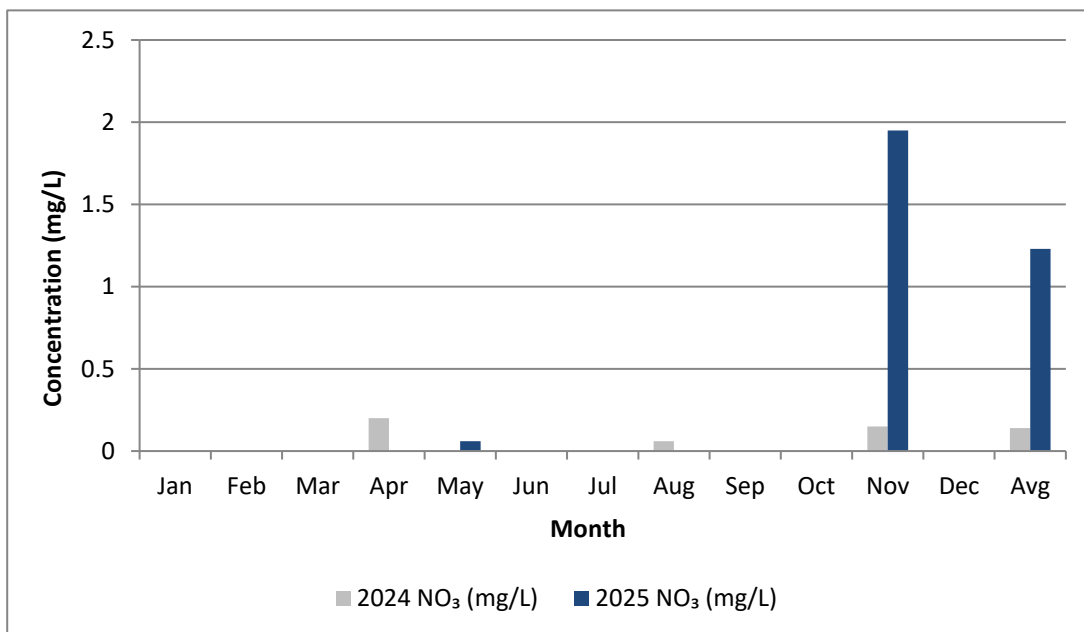
Figure 14: Effluent  $\text{NO}_3$  Concentrations 2024 to 2025

In 2025, the average effluent Nitrate was 1.23 mg/L, which is a significant increase from 2024 (refer to Figure 14). Elevated nitrate concentrations observed in November 2025 relative to 2024 are indicative of more complete ammonia removal during the treatment season.

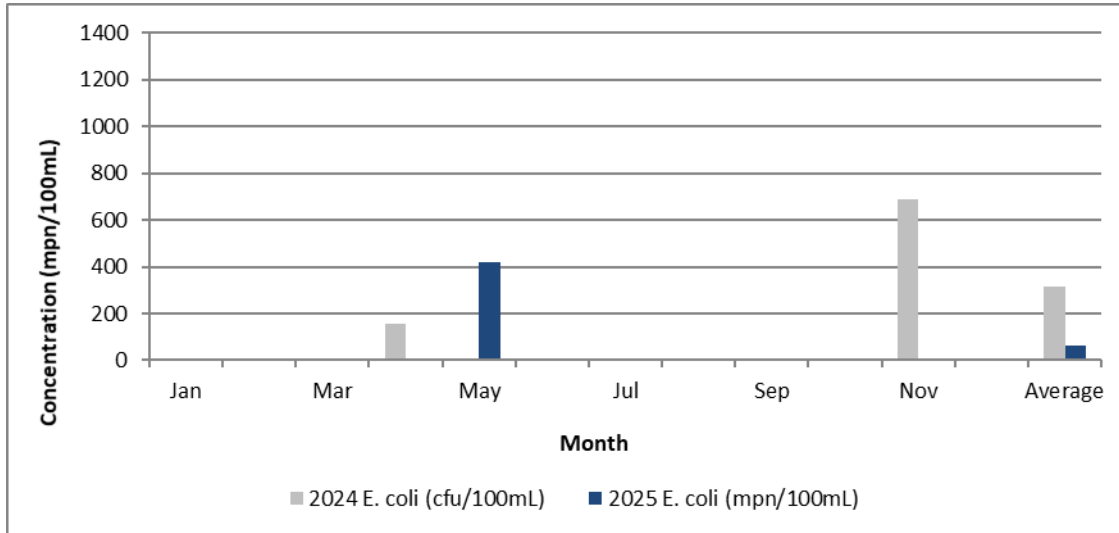
Figure 15: Effluent *E. coli* Concentrations 2024 to 2025

In 2025, SGS lab updated their E. coli measurement method to mpn/100mL (most probable number) rather than cfu/100mL. This is reflected on Figure 15 below.

The monthly geometric mean effluent E. coli concentration in 2025 was 63 mpn/100mL, which is an 80% decrease from 2024 (refer to Figure 15).

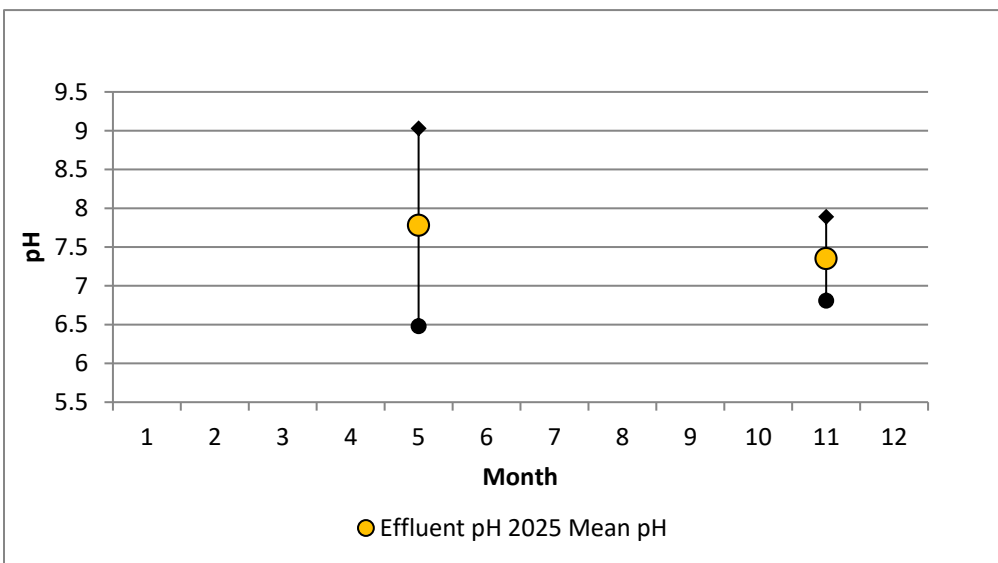
Figure 16: Effluent pH Values 2025

In 2025, pH in the Parkhill Sewage Lagoons final effluent ranged from 6.48 to 9.03 (refer to Figure 16). There are no minimum ECA limits or objectives for pH, however the standard operating range is 6.5 to 8.5.
